**West Otter Lake Aquatic Vegetation Management Plan
Update, Steuben County, Indiana
2006**

West Otter Lake Association
60 Ln 201a West Otter Lake
Angola, IN 46703

Prepared by:
Aquatic Enhancement & Survey, Inc.
P.O. Box 1036
Angola, IN 46703

December 3, 2006

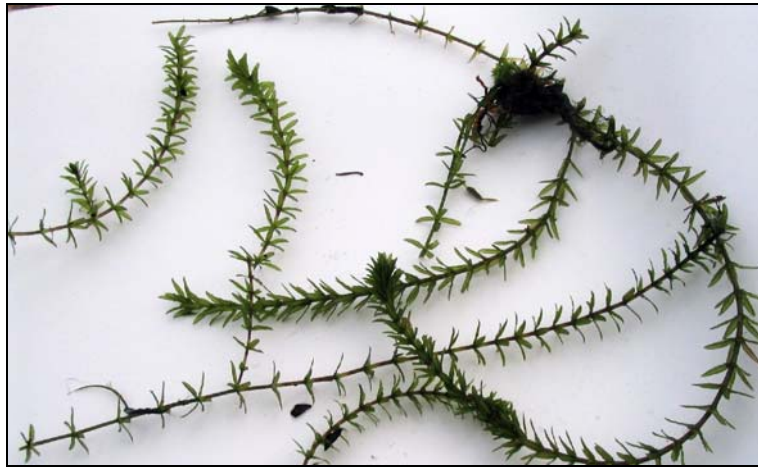
Figure 19 Hydrilla is similar in appearance to the native plant *Elodea canadensis* and also Brazilian elodea, an exotic also recently found in Indiana. It forms long stems containing many whorls of short leaves.

Hydrilla strongly resembles the native aquatic plant *Elodea canadensis* and the introduced species Brazilian elodea *Egeria Densa*. Both these species can be found in Indiana although the occurrence of Brazilian elodea has been very limited thus far. Native *Elodea* is a part of the West Otter Lake plant community. Hydrilla is a long slender plant that sometimes branches and has short leaves arranged around the stem in a star-like (whorled) pattern. Characteristics which differentiate Hydrilla from *Elodea* and Brazilian *Elodea* include a typical leaf count of five in the whorl. Brazilian elodea typically has four to six leaves but never three, and native *Elodea* usually has three. (fig 20) Small teeth are also present on the midrib of Hydrilla leaves and may give the plant a “rough” feel.

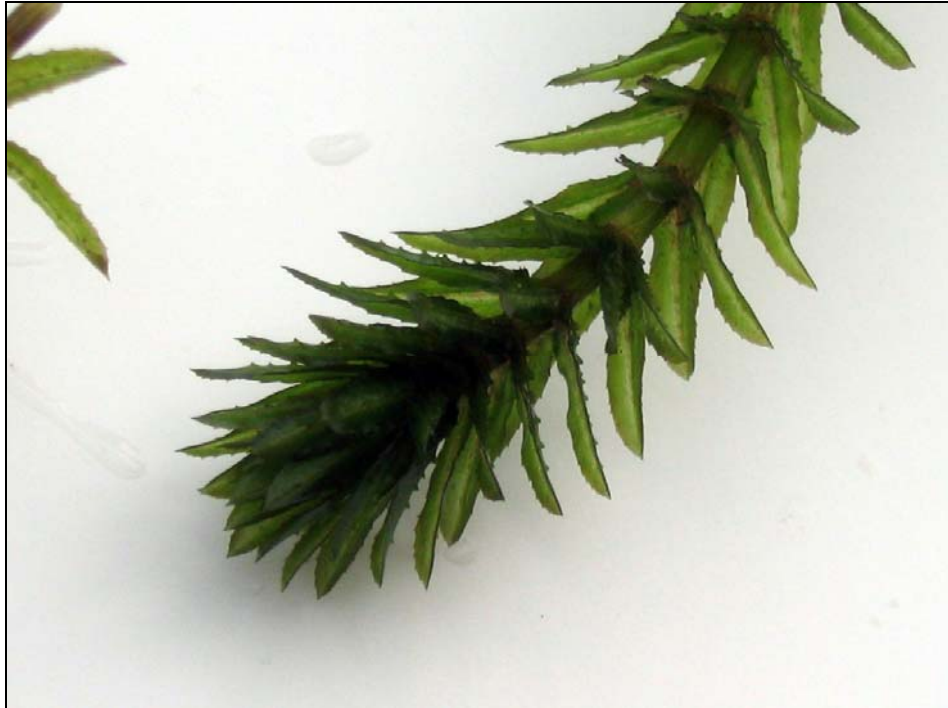
Figure 21 Edges of Hydrilla leaves have fine serrations visible upon close examination

Hydrilla also has small serrations along the leaf edges (fig 21). Another distinguishing characteristic of Hydrilla is the presence of tubers (.2 to .4 inch long off-white structures attached to the root) (fig 22).

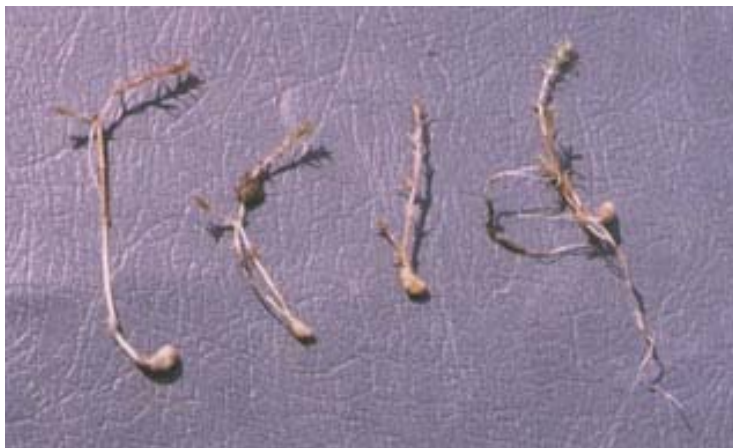
Figure 22 Hydrilla plants with tubers attached
